NETTIE, W.VA.
NW 1/4 RICHWOOD 15 QUADRANGLE
N3807.5—W8037.5/7.5

LANDSLIDES AND RELATED FEATURES

OF THE NETTIE, W.VA. QUADRANGLE

OPEN FILE MAP 85-80 (B-11)

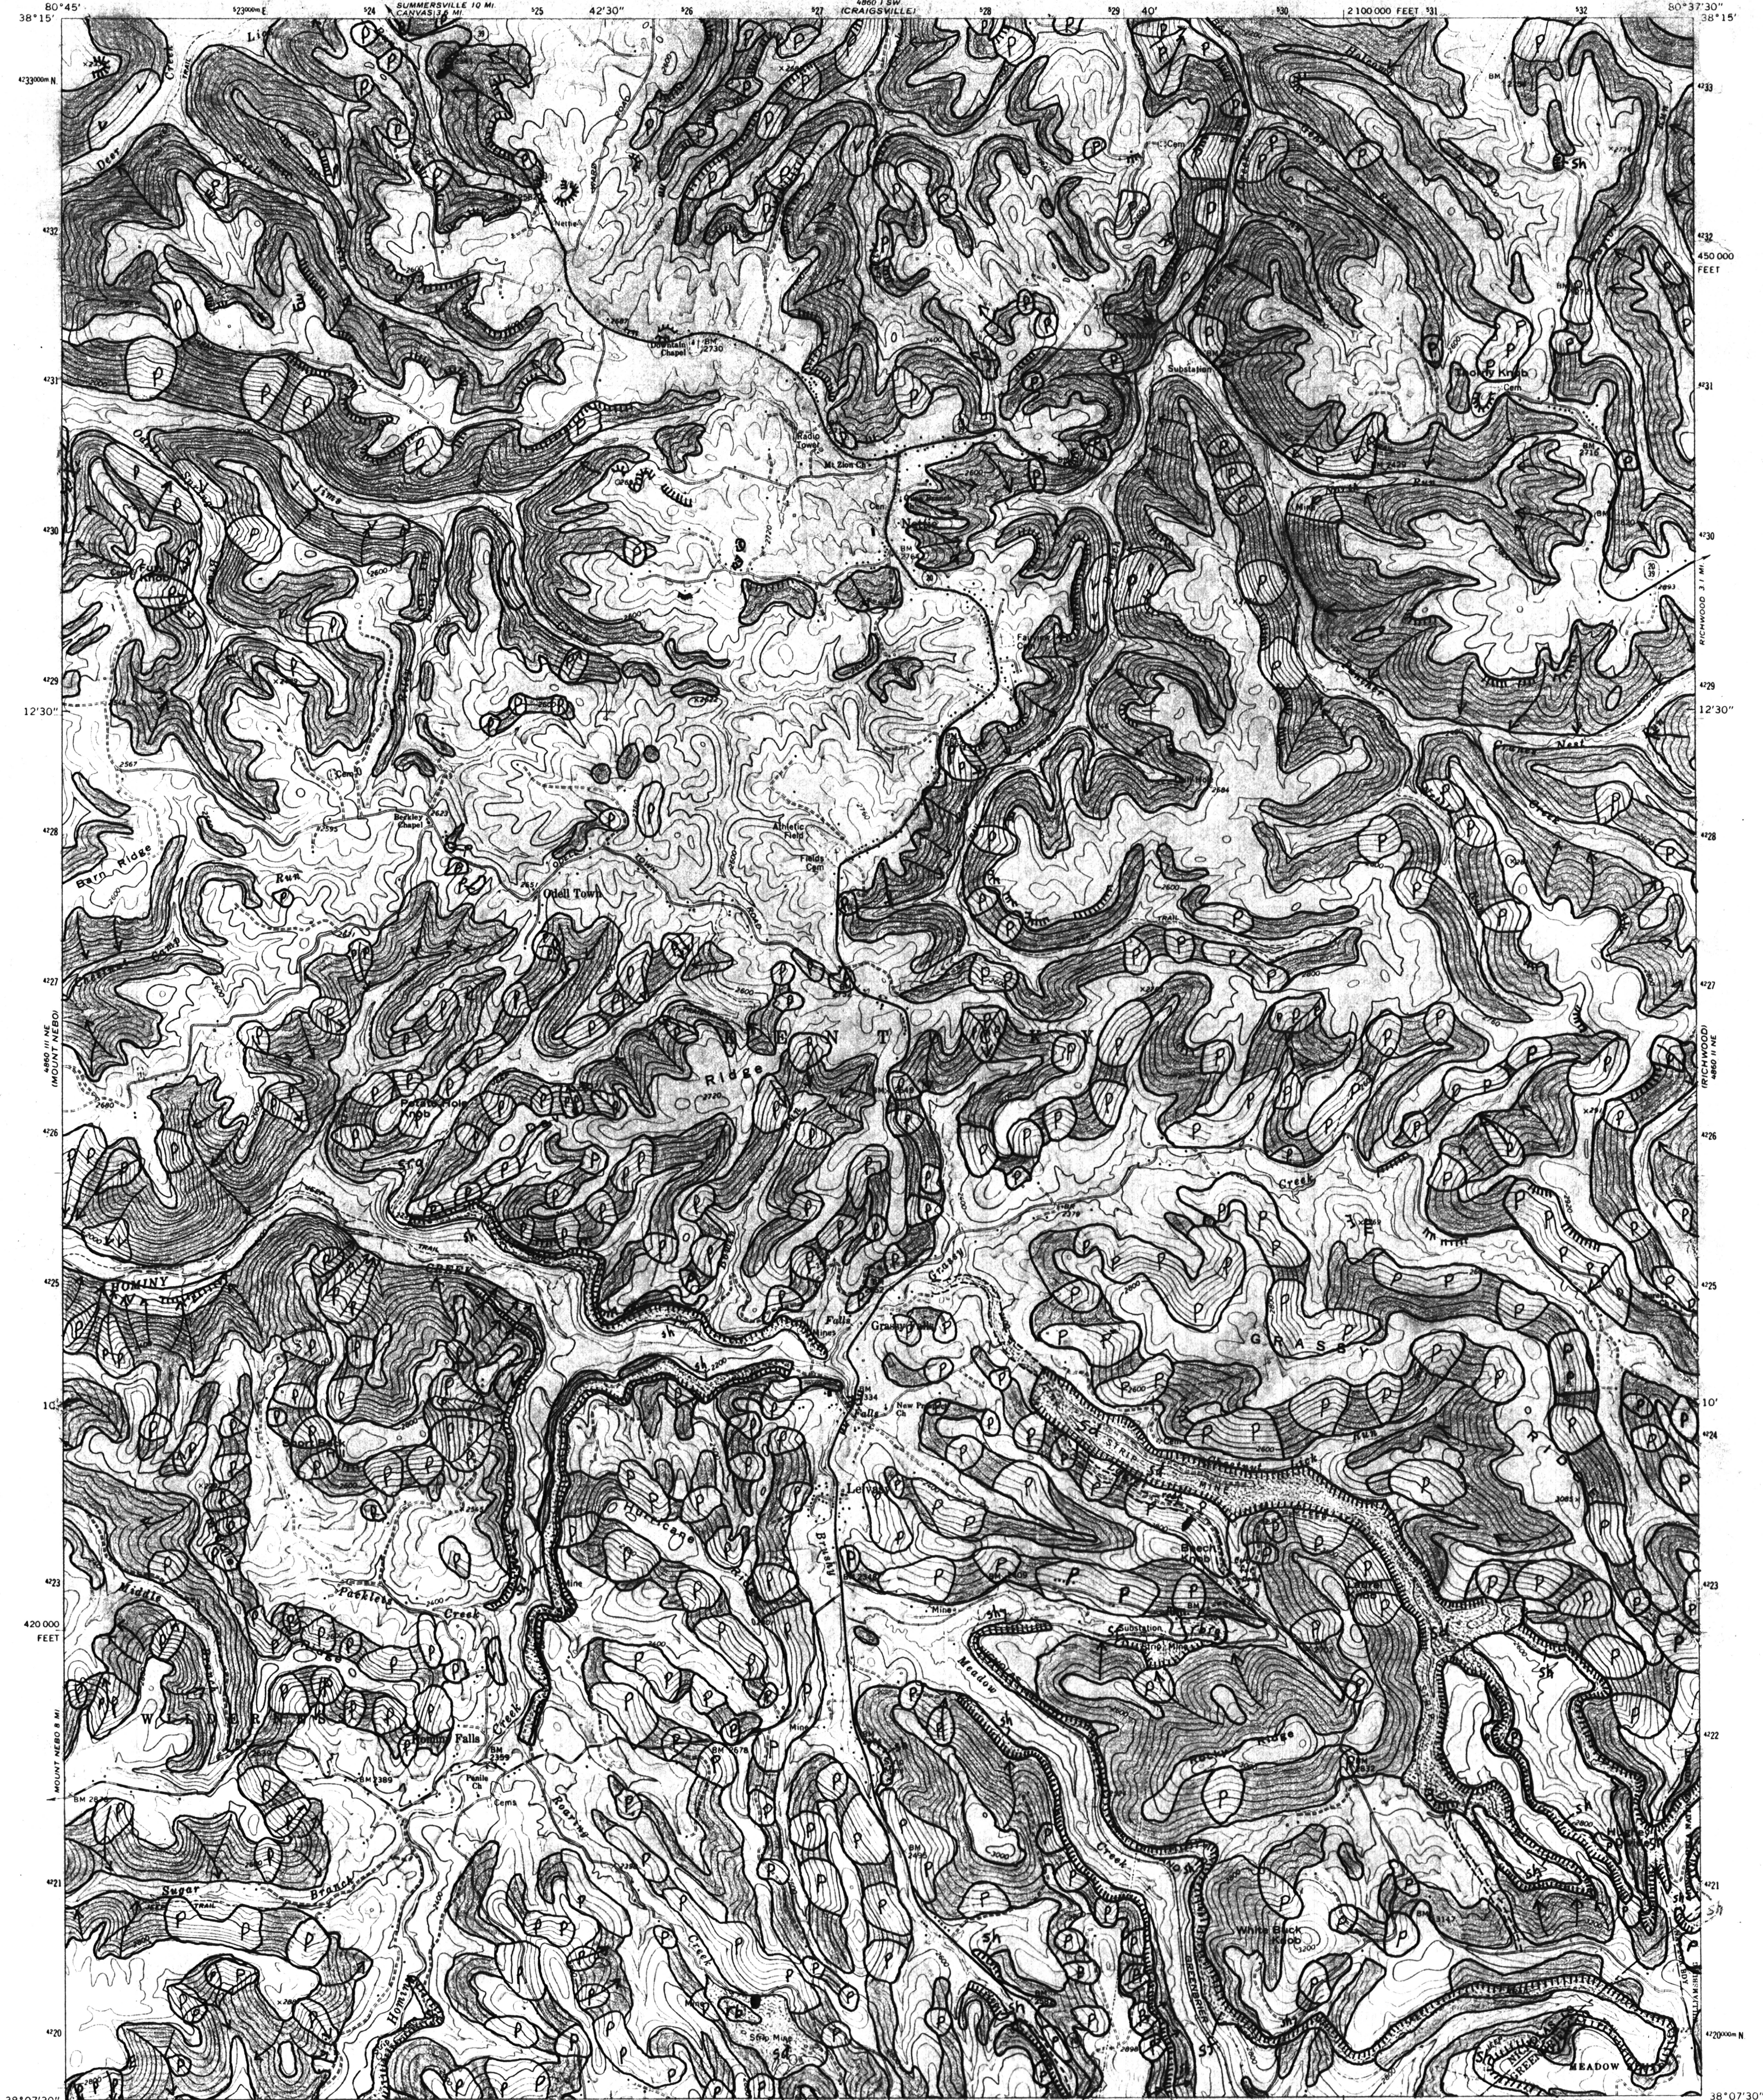
Landslides and related features interpreted
from aerial photographs:
1:60,000 SCALE BLACK AND WHITE 1960
1:125,000 SCALE COLOR INFRARED 1973

ACTIVE OR RECENTLY ACTIVE LANDSLIDE
Complex landslide composed of earthflow, debris
slide, earth and rock slump. Identified from
historical records, and from scars, debris and
other field evidence. Ground extremely unstable,
sliding accelerated by excavation, loading and
changes in drainage conditions. May include
areas with several active slides too small to
be shown separately.

OLD LANDSLIDE
Area of extensive hummocky ground caused by
earthflow and earth and rock slump. Lacks
clear evidence of active sliding. Relatively
stable in natural, undisturbed state,
generally not affected by small structures properly
sited in areas away from the edge of the toe,
can be reactivated by extensive, rapid exca-
vation, loading, and changes in ground water and
surface water conditions. Area of old landslide
probably includes recent ones not identified
from field evidence or otherwise documented.
Upslope boundary of landslide generally defined
by modified scarp, but downslope (toe) may be
gradational and not well defined.

COLLUVIAL SLOPE
Valley wall along major streams with slope as
steep as 40° (85%), stony, clayey silt soil up
to 50 ft. (15 m) thick, commonly buttressed by
a terrace or bench at the toe of the slope, very
susceptible to sliding by cutting of toe area,
removal of terrace or bench, and overloading,
slide commonly activated without apparent cause.

AREAS SUSCEPTIBLE TO DEBRIS FLOWS AND DEBRIS
AVALANCHES
Primarily shallow, narrow ravines and chutes with
accumulation of stony colluvium generally 10 ft.
(3 m) or less in thickness, susceptible to rapid
movement during intense rainfall. Most ravines
and chutes designated show evidence of former
debris flows and avalanches. Symbol 'a' desig-
nates historical debris flow or debris avalanche.

AREAS SUSCEPTIBLE TO ROCKFALL
Steep, locally vertical, natural and man-made
slopes and cliffs, 15 ft. (4.5 m) or more high,
formed dominantly of sandstone, limestone, sandy
shale, mudstone and claystone. Interbedded mud-
stone, claystone and shale weather rapidly leaving
sandstone and limestone rock faces unsupported.

SOIL AND ROCK SUSCEPTIBLE TO LANDSLIDING
Soil and rock similar to that involved in land-
slides elsewhere in map area; primarily areas
underlain by claystone, mudstone and shale
associated with other rock types. Rock weathers
rapidly on exposure forming clayey soil highly
susceptible to sliding. Includes coves (U-shaped,
shallow valleys) containing thick layers of clayey
soil that are very susceptible to sliding where
excavation breaks continuity of slope and where
overloaded by artificial fill.

AREAS LEAST PRONE TO LANDSLIDES
Map areas in which no patterns or symbols are shown;
primarily valley floors, ridge tops and broad
benches; modification by excavation and fill may
lead to local landslides.
